MATERIALS RESEARCH LABORATORIES

MRL-R-953

USE OF ULTRASONICS TO DETERMINE THE CRACK SIZE
IN HIGH STRENGTH STEEL GUN BARRELS

G. Wulf*

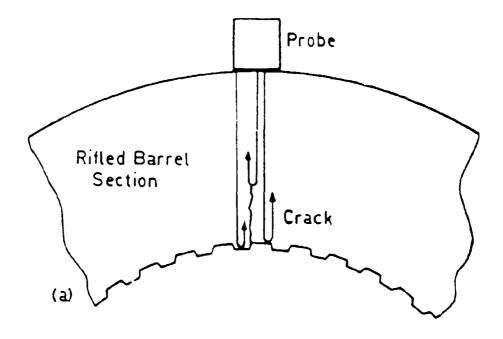
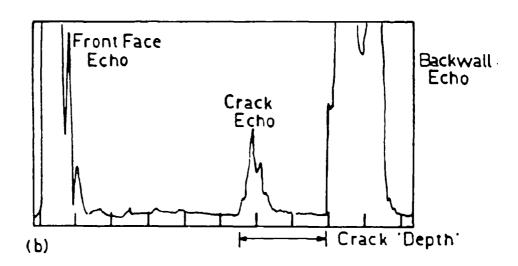
FIGURE 2 Longitudinal wave

Unlike some of the above ultrasonic techniques this method uses a single probe and depends on the reflection of longitudinal waves from the crack tip, the radial depth of the crack being indicated by the distance between the crack tip echo and the back wall echo (Figure 2(a)). The first reported success using this technique was by Miller [5] in 1970, Hunt [3] also successfully used this technique on gun barrels, although he reports earlier failures on thin wall gun liners. The success with gun barrels is mainly due to the type of steel used and the thickness of the section. The use of clean, fine grained steels reduces scatter from inclusions and allows the use of the high amplifier gains necessary to obtain a sufficient indication from the weak crack tip echo, while the thick section of the barrel allows an adequate separation of the crack echos from the massive front face echo.

reflected from side of crack (a) (c)

partially transmitted past crack reflected from tip of crack

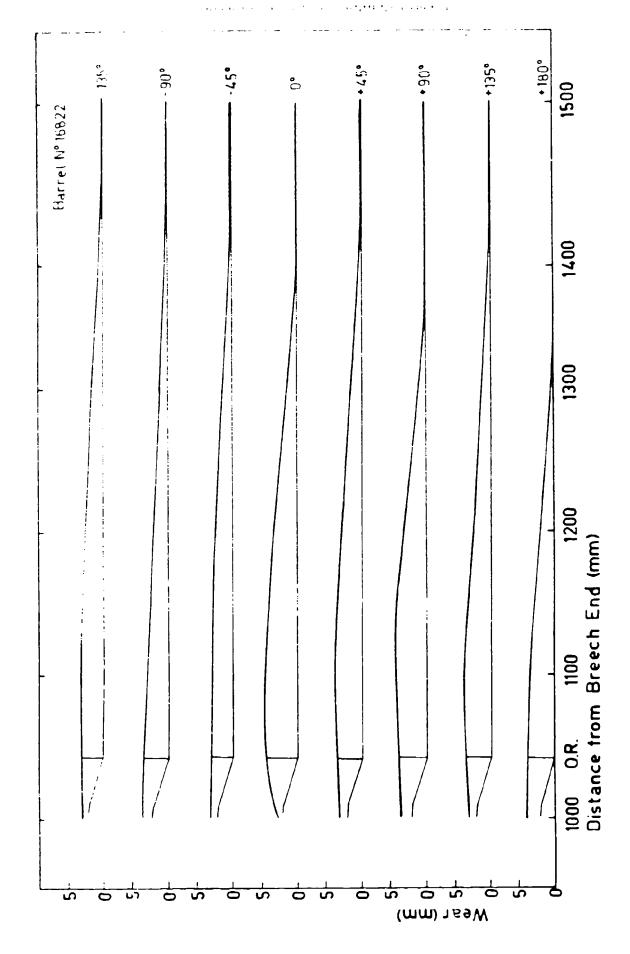
The erosion of the barrels made the identification of the cracks difficult, especially as these were measured to be about 2-3 mm. Erosion caused non-uniform movement of the back wall echo, often with a separate echo from the main back echo and similar to that from a crack. 'True' cracks were distinguished by their movement back into the main back wall echo as the probe passed over and then moved away from their location. This was a particular problem during the second series of examinations.

Brosnon profiles for Garrel No. 16763 after (1889 Founds). i lataret e

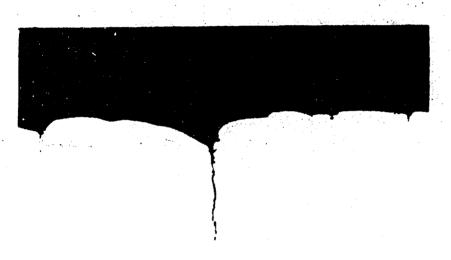
Examination of the No. 16763 barrel section, using both contact and immersion techniques, showed that the previous circumferential 'crack' indication obtained were associated with erosion 'gutters' and craze cracking. This was confirmed later by sectioning, when large 3 to 4 mm cracks were found but these were located in the walls of 4 to 5 mm deep gutters (Figure 12).

FIGURE 12 Section from barrel No. 16763 showing a crack in the wall of a 5 mm deep gutter. (X50)
